# Safety Advice

## Camera mast winch failure

Ref: NRA21-03

Location: Rigton CCTV level crossing

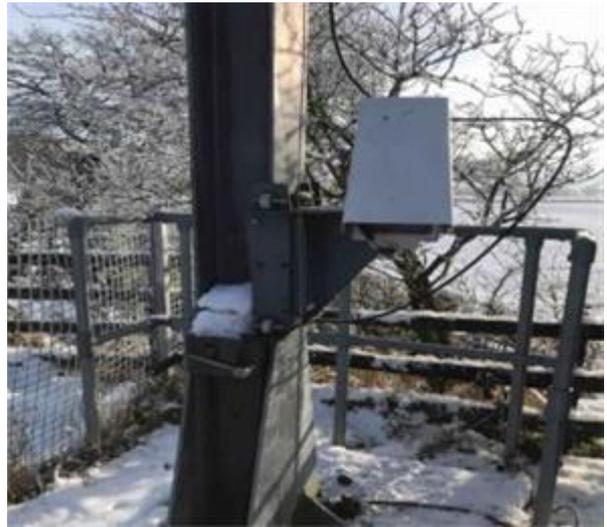
On 15th January 2021, a CCTV camera platform fell down a mast, narrowly avoiding injury to a signalling technician at Rigton CCTV level crossing.

The initial findings are that a component failure within the winch mechanism failed, resulting in the camera platform rapidly descending the mast. It struck the signalling technician's helmet with a glancing blow.

The CCTV platform winch has an emergency brake mechanism intended to prevent this type of incident. However it is believed ice and snow led to the failure. A full review of the equipment is underway.

- Never lower CCTV cameras without the presence of plant technicians.
- If a single camera should fail, the second camera shall be used and a fault raised with the relevant plant team.
- If both cameras fail, escalate the fault level. Plant staff must be present before either camera is lowered.
- Maintenance staff operating the winch to lower the camera shall ensure they are in a safe position and there are no other people in the work area below the camera platform.
- These are interim measures until a full review of this type of winch gear is concluded.
